2022 Endangered Buildings List

Adopted April 20, 2022

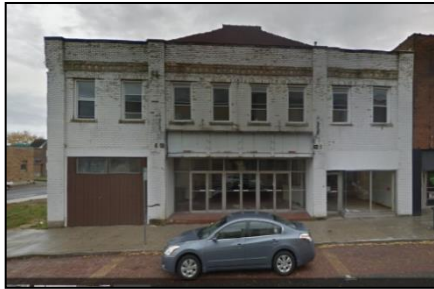
BROADWAY THEATRE – 805 BROADWAY

In its heyday, the Broadway Theatre was associated with both 20th Century Fox and Paramount Pictures. It originally opened with a showing of the motion picture *The Sheik*, starring Rudolph Valentino. It was first-rate, with state-of-the-art equipment, an orchestra pit, stage facilities, and a grand marquee. The main floor and the balcony had a total seating capacity for 1,200 persons. Today, the 1921 theatre stands vacant, and the marquee is long gone. In April 2021, the City condemned the building due to a fire that destroyed the roof and damaged the upper story of the front

section. A few months later, a nonprofit corporation acquired the building, with plans to rehabilitate and repurpose it as a multi-purpose venue. However, no progress has been made, and the City is moving forward with soliciting bids for demolishing the entire building. The theatre was added to the National Register of Historic Places in 2015. (*On Endangered Buildings List since 2012*)

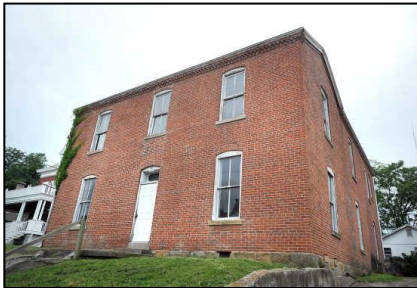
127 SOUTH LORIMIER STREET

The house at 127 South Lorimier Street reflects the Missouri German Vernacular style, which was once prevalent in Cape Girardeau. It has many of the character-defining features, such as a rectangular footprint, close proximity to the street, a brick façade, a stone foundation, brick arches over double-hung sash windows, and a low pitched roof with an end chimney. Unlike most houses of this style, it features two stories. The house appears to be vacant and certain elements, including the windows, the bay window, and the rear addition, are damaged and/or deteriorating. If

ignored, the deterioration will increase and over time could lead to more serious conditions affecting the building's historic and architectural integrity. (*On Endangered Buildings List since 2013*)

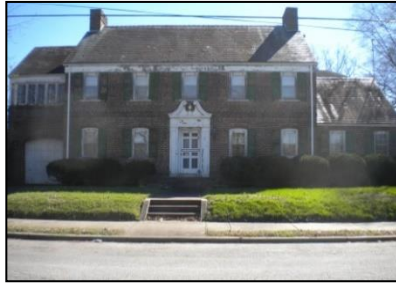
831 NORTH STREET

An example of the Colonial Revival style can be found at the southeast corner of North and North Pacific Streets. This large, two-story brick house features a symmetrical façade, a medium pitched, side gable roof with narrow eaves, dual chimneys, and a ram's head door pediment. It was once awarded the winner of a Christmas lighting contest. The house is deteriorating quickly due to missing roof shingles, missing mortar from the brick, and severely peeling paint. The property is valuable due to its close proximity to Southeast Missouri State University's main campus, but if left to continue

deteriorating, it could reach a point where the land is worth more without the house than with it. (*On Endangered Buildings List since 2017*)

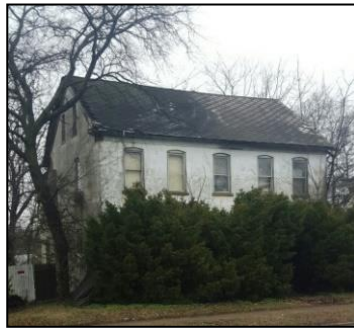
207 NORTH HENDERSON AVENUE

This two-and-one-half story house was built circa 1900. It features brick arches over double hung windows and limestone lintels, characteristics of the Missouri German Vernacular style. The cornice line is not visible due to stucco that was applied after the original building's construction. The house is deteriorating in many places, including the roof, which is rotting away; the windows, some of which are broken; and the stucco, which is crumbling. The property has not been maintained in several years, and the house will only get worse if these issues are not addressed. (*On Endangered Buildings List since 2018*)

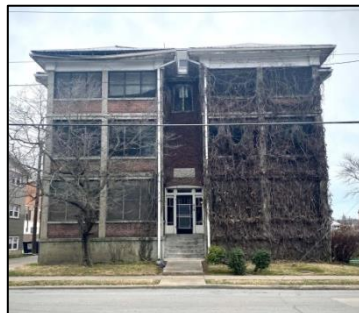
419 BELLEVUE STREET

The three-story, U-shaped apartment building at 419 Bellevue Street is one of the oldest apartment buildings in Cape Girardeau. Built in 1913, the building features brick construction on a concrete foundation and contains Colonial Revival elements. The side and rear elevations contain numerous windows and segmental arches. The building is in severe need of maintenance, as evidenced by the damaged fascia, soffit, and gutter on the front elevation. Overgrown vines cover nearly half of the façade.

These conditions can lead to water damage, mold, and other problems that undermine the architectural and structural integrity of the building. *(On Endangered Buildings List since 2021)*

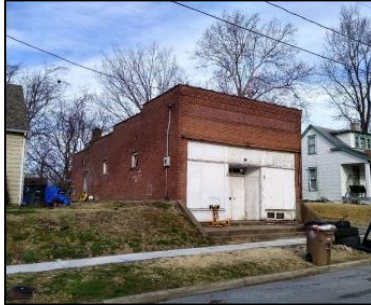
543 SOUTH PACIFIC STREET

This one-part commercial block building is located in a residential neighborhood. It was built around 1930 and served as a local grocery store until the 1960s when its use changed to a commercial mailing service. The symmetrical storefront features a recessed double door flanked by large display windows. The wall above the storefront contains a long, narrow rectangular panel of recessed brick courses, with a brick corbel cornice above. Additional details include transom lights and bulkhead panels. The windows have been covered with plywood, and some of the wood panels are missing from the bulkhead. The rear of the building has collapsed, creating a dangerous condition

that must be addressed immediately. *(Added to Watch List in 2020; moved to Endangered Buildings List in 2022)*

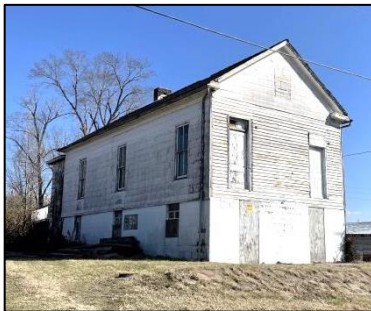
412 ASHER STREET

This long, narrow house reflects the Missouri German Vernacular style. It features a two-door entrance on the front gable, with a transom light above each door. The roof and central chimney appear to be original to the construction period. Unlike most German Vernacular houses, this house features clapboard siding rather than brick. The white paint has mostly worn off in several places, leaving the wood siding, doors, windows, and other elements exposed to the weather. If the exposed wood is not painted or sealed soon, it will deteriorate rapidly and cause major damage to the house. *(Added to Endangered Buildings List in 2022)*

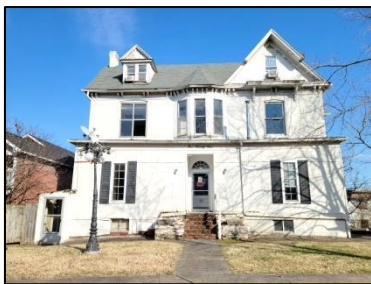
124 SOUTH LORIMIER STREET

Constructed around 1915, this two-and-one-half story brick house contains several character-defining features consistent with the Queen Anne style, including a rectangular floor plan with a cross gable roof and a chimney at each end. It also contains decorative brackets on the soffit and fish scale shingle siding and dentils near the roofline and in the gable and dormer. The house was expanded in the 1930s, presumably when it was converted from a single-family residence to apartments. The additions obscure much of the original house on the first floor. However, several of the character-defining features are still

visible on the second floor. The house is part of the Courthouse–Seminary Neighborhood Historic District in the National Register of Historic Places. Water damage is evident in several places, mostly due to roof issues, missing mortar, and paint wear. Water damage greatly accelerates deterioration, putting buildings like this at risk. *(Added to Endangered Buildings List in 2022)*

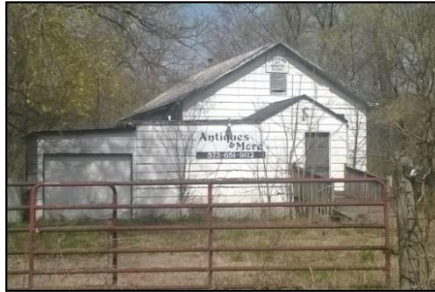
JUDEN SCHOOL – 900 WEST CAPE ROCK DRIVE

This former schoolhouse was built in 1854 and was in service until 1960. It features original wood floors and windows, as well as a blackboard. The building is vulnerable to flooding, particularly the basement, and the roof needs to be replaced. It is endangered in the sense that historic schoolhouses are disappearing from the landscape across the nation. If not properly preserved, it could be among those that once were. *(Added to Endangered Buildings List in 2015; moved to and on Watch List since 2016)*

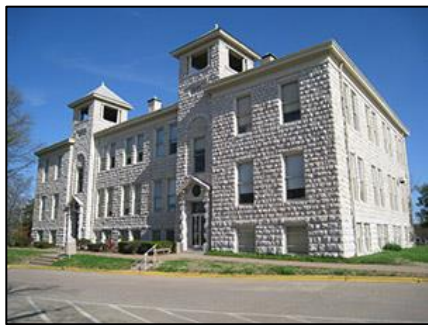
THE ART BUILDING – 940 ACADEMIC DRIVE

Located on the main campus of Southeast Missouri State University, the Art Building opened in 1903 and was originally used as a training school. In the 1930s, the building housed the University's agriculture program. Since that time, it has been home to other programs, including anthropology, arts and home economics, and foreign languages. The stone block building features a pair of towered entrances, dentils beneath the cornice, and ornate columns. Like Academic Hall, Carnahan Hall, and other notable historic buildings on the campus, the Art Building embodies the University's rich heritage and contributes to its

unique setting. Deferred maintenance has resulted in several of its rooms being condemned. While there are no apparent plans to demolish the building, the University has demolished several other historic buildings and structures in recent years for redevelopment projects. *(On Watch List since 2019)*

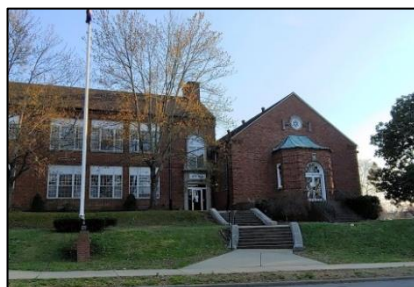
OLD CITY HALL / LORIMIER SCHOOL – 401 INDEPENDENCE STREET

The two-story brick building at 401 Independence Street was built in 1937 as a replacement for the original Lorimier School, which was built in the 1870s on the same site. The "new" Lorimier School served generations of children until it closed in the mid-1970s due to low enrollment. In 1978, the building was repurposed as the City Hall. Over the years, the historic exterior of the building has been mostly kept intact. The cornerstone, brick quoins, ornate entrances, rounded windows, and other details are still visible today. City Hall recently relocated to a new facility at 44 North Lorimier Street,

which incorporated and renovated the Common Pleas Courthouse and the Carnegie Library. The City Hall relocation leaves this building vacant and without a plan for reuse. *(Added to Endangered Buildings List in 2019; moved to and on Watch List since 2020)*

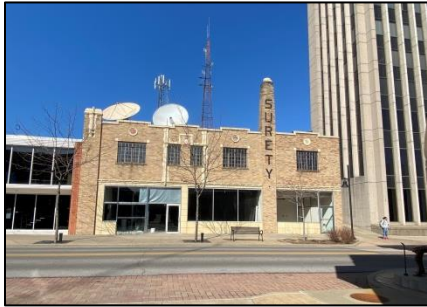
SURETY SAVINGS AND LOAN ASSOCIATION BUILDING – 318 & 320 BROADWAY

This ornate two-story building was built in the late 1920s and was originally known as the Cherry Florist building. It was later purchased by the Surety Savings and Loan Association, which changed the vertical sign from the word “CHERRY” to “SURETY”. Designed in the Spanish Colonial Revival style, the building features buff-colored brick and several terra cotta elements, including the belt course, parapet, pilasters, and medallions. It is listed in the National Register of Historic Places as part of the Broadway and North Fountain Streets Historic District. Today, the building is sandwiched between the KFVS

skyscraper and the River Radio building. It has been vacant for several years. The foundation contains cracks and one of the downspouts is missing, allowing water to enter the building and cause damage. Graffiti is present on the east wall. These are signs of a building lacking proper maintenance. Over time, this can lead to serious issues, making the building less likely to be rehabilitated in the future. (*On Watch List since 2020*)

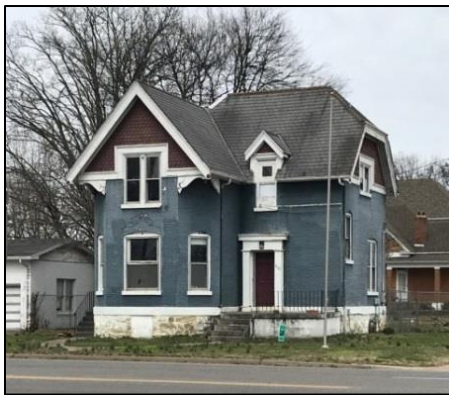
802 WILLIAM STREET

The dominant front-facing gable and asymmetrical façade of this two-story brick house at the northwest corner of William and South Ellis Streets exemplify the Queen Anne style. Built in 1890, it contains several additional character-defining features such as fish scale shingle siding, scroll brackets, a clipped gable roof, and windows that interrupt the cornice line. The house has a number of maintenance issues that need to be addressed. Roof shingle deterioration, cracks along the porch foundation, missing mortar between the bricks, and rotting trim are evident. The prominent location of the house along William Street presents both a threat and an opportunity. The condition of the house may be a deciding factor. (*On Watch List since 2020*)

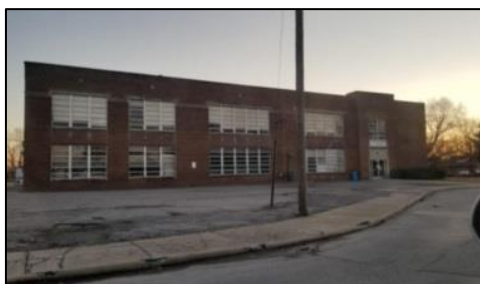
MAY GREENE SCHOOL – 1000 SOUTH RANNEY AVENUE

Located near Fort D, May Greene School was built in 1920 and was originally named South Grade School. It was later renamed in honor of a prominent teacher who taught in the school district for over five decades. May Greene School was the first school in the area to become integrated. The integration occurred in 1953 after John S. Cobb School on Merriwether Street was destroyed by a fire, prompting the reassignment of its students, all African-American, to the original Jefferson School on Jefferson Street. The white

students who had been attending Jefferson School were reassigned to May Greene School, which at the time had an all African-American student body. May Greene School was in service until 1999 when the new Blanchard Elementary School opened on North Sprigg Street and the students were reassigned. Today, the building is used by a church for a faith-based after-school program. While the building is not delapidated, it is showing signs of deterioration as well as vandalism. School buildings that no longer

serve their original purpose often end up being demolished due to lack of repurposing options and increased maintenance costs. *(Added to Endangered Buildings List in 2020; moved to and on Watch List since 2021)*

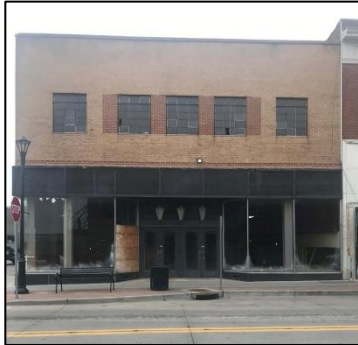
F.W. WOOLWORTH CO. BUILDING – 1 NORTH MAIN STREET

The two-part commercial block building at 1 North Main Street was constructed in 1950 for F.W. Woolworth Co., which operated a successful five-and-dime store in the block and needed to expand. The new and improved store, which included a lunch counter, was a major shopping destination for many years. It eventually closed in 1977. The building was later occupied by a furniture store, which operated in it for over a decade, followed by a few other businesses. It has been vacant for several years and has not been maintained, as evidenced by the broken windows. In 2016, a local development company expressed interest in renovating the building for an organic market and a restaurant. To date, no progress has been made. The building is listed in the National Register of Historic

Places as part of the Main-Spanish Commercial Historic District. *(Added to Endangered Buildings List in 2013; moved to Watch List in 2017; removed in 2019; re-added to and on Watch List since 2021)*

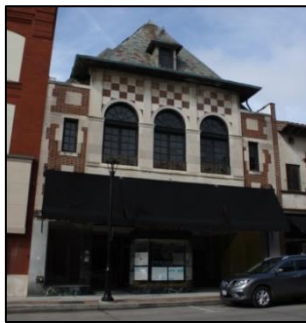
HECHT'S BUILDING – 107 NORTH MAIN STREET

One of the most unique buildings in downtown Cape Girardeau, this elaborate two-story building was designed by Tom P. Barnett and built by J.W. Gerhardt, both of whom worked on the Southeast Missourian building on Broadway. It was built for Louis Hecht, who opened a clothing store at 135 North Main Street in 1917 and closed it a year later to serve in World War I. He returned in 1919 and reopened the store in a new location at 127 North Main Street. The store moved to 107 North Main Street upon completion of the building in 1927. The Tudor Revival style building features a recessed entry with an arched ceiling containing a highly ornate angel motif, an octagonal glass display case in front of the entry, a high pitched hip roof with

a dormer window, three arched windows on the second story, and intricate patterns of brick and stone on the façade. The building has been vacant for several years, and it is showing signs of deferred maintenance. It is listed in the National Register of Historic Places as part of the Cape Girardeau Commercial Historic District. *(On Watch List since 2021)*

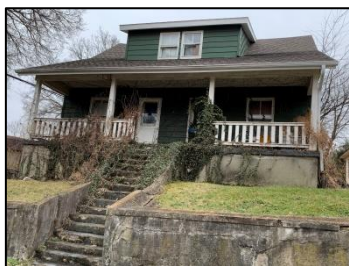
419 NORTH STREET

This Craftsman Bungalow house is one of several that can be seen in the city's older neighborhoods. It features a side gable roof, a shed dormer with a pair of two-over-two sash windows, wide overhanging eaves, horizontal siding, a full-length front porch situated under the eaves, and a stone foundation. The porch is being invaded by vines which, if allowed to further grow uncontrolled, will eventually cause damage to the house. The concrete steps leading to the porch and the retaining walls along the sidewalk are severely deteriorated. *(On Watch List since 2021)*

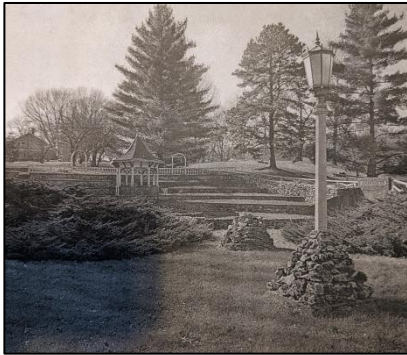
KELSO ARBORETA – 2009 OLD SPRIGG STREET ROAD

Located on what was once an 800-acre farm owned by Judge I.R. Kelso, the Kelso Arboreta is a unique and beautiful work of landscape architecture. Built in the 1920s to solve a sinkhole problem, the arboreta served for several years as an outdoor stage for numerous performances as well as a favorite spot for picnics and nature studies. It features a sunken garden with terraces made from stone obtained from a quarry that once existed on the site of Houck Stadium. Other features include a stone fence along the street, a gazebo, a light post, and a pair of short walls inscribed with “ARBORETA” flanking the driveway. Aside from its design, the arboreta is significant because of its original owner. Kelso was a

lawyer, a civic leader, and a businessman who was instrumental in the growth of the utility industry in the 20th century. He helped establish the Cape Rock Water Plant and founded the Springdale Bird Sanctuary, now owned by Southeast Missouri State University. In the 1940s, he fought to keep the federal government from demolishing the Common Pleas Courthouse and the Carnegie Library for a new post office. The property containing the arboreta is currently for sale, and while it is hoped the next owner will continue to preserve it, there are no guarantees. *(Added to Watch List in 2022)*

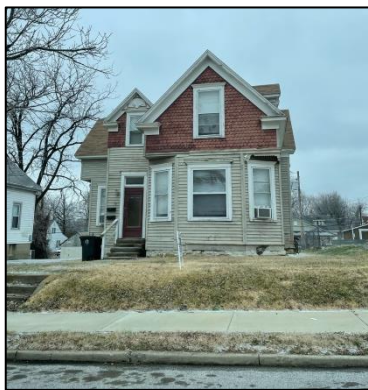
19 SOUTH BENTON STREET

This one-and-one-half story house was built circa 1920 and is a good example of the Queen Anne style popularized in the late 19th century and early 20th century. It features an asymmetrical cross gable, cut-away bays on the east and south elevations, fish scale shingle siding, a wooden fan detail above one of the upper windows, and ornamentation at the corners above the first floor windows. There is heavy paint peeling on the first floor above the windows and paint chipping in other places. If the paint is allowed to continue deteriorating, it will soon lead to deterioration of the wood and create more significant problems for the owner. *(Added to Watch List in 2022)*

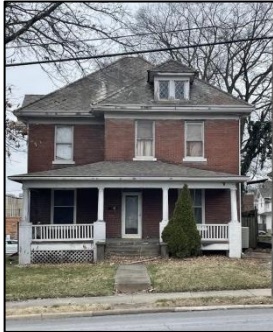
221 NORTH SPRIGG STREET

Built in 1910, this two-and-one-half story brick house reflects the American Foursquare style, as evidenced by its boxy design, hipped roof, center dormer, and large front porch. A portion of the façade is recessed, adding articulation to what would otherwise be a wide, flat elevation. As was typical for the American Foursquare style, the house contains no decorative features other than the lattice windows and porch columns. The exterior of the house is in need of general repair and maintenance, from the damaged asbestos tile roof to the leaning porch columns and supports. There is also significant paint wear and wood damage in the dormer area. All of these items need to be addressed soon to prevent more serious deterioration. (*Added to Watch List in 2022*)
